Addendum to:

**Archaeological and Architectural Assessment of Charles Fort, St. Kitts,
West Indies**

Charles Fort Archaeological and Historical Project Report No. 3

September 2000

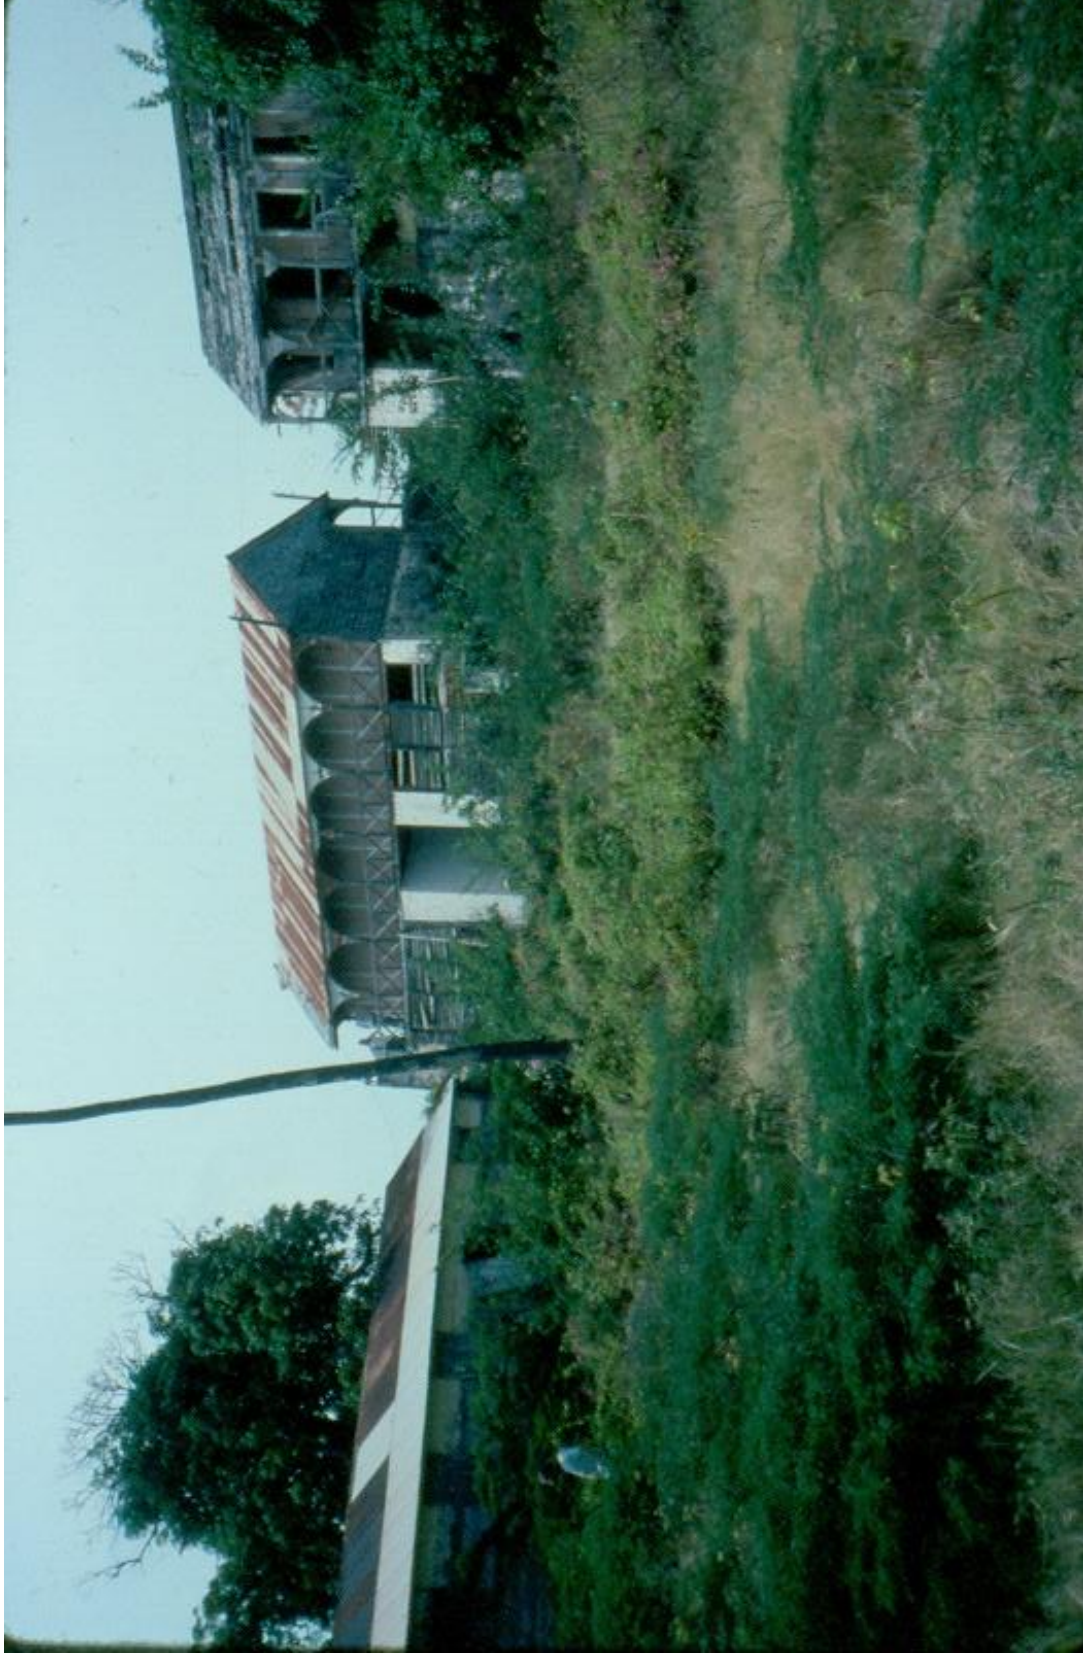
Structure 7 is the administrative structure built atop the entrance gate to the fort. This structure has porches along the length of the east and west sides. In 2000 the porch on the west side had been completely lost except for a remnant of a shake covered wall at the south end of the porch (Schroedl 2000b: Figure 22 and 24). The complete porch is clearly shown in Figure 1. It confirms that the design and construction of the west-side porch was essentially identical to the east side porch, but that it did not have a dormer as found on the east side of the building. A further difference between the two porches is that the west side porch has cross pieces in the hand rail between the porch

support posts. The 1997 photograph also shows all the shutters and doors intact, while most were missing or badly damaged when the site was visited in 2000. In addition, Figure 1 shows that Structure 7 was covered with a corrugated metal roof that was missing in 2000.

Structure 11, a two story building, is immediately south of Structure 7 and is shown to the right of it in Figure 1. It was used as living quarters for nurses and orderlies. When recorded in May-June 2000, Structure 11, except for the foundation, stairways, and north first floor wall, was completely destroyed (Schroedl 2000: Figure 37,38, and 39). Details of the lower story construction are indiscernible in Figure 1, but most of the second story is visible. It was previously hypothesized (Schroedl 2000: 18) that construction of the second story was similar to Structure 7, and Figure 1 shows that this is the case. The construction of the west elevation includes door and window openings, shutters, hand railings, and porch support posts virtually identical to Structure 7. As shown in Figure 1, by 1997, the roof of Structure 11, had been entirely removed from the west side of the structure.

Figure 1. Structure 7, administrative building, at center; Structure 11, nurses quarters at right; Structure 8 assembly building at left; view to the north northeast

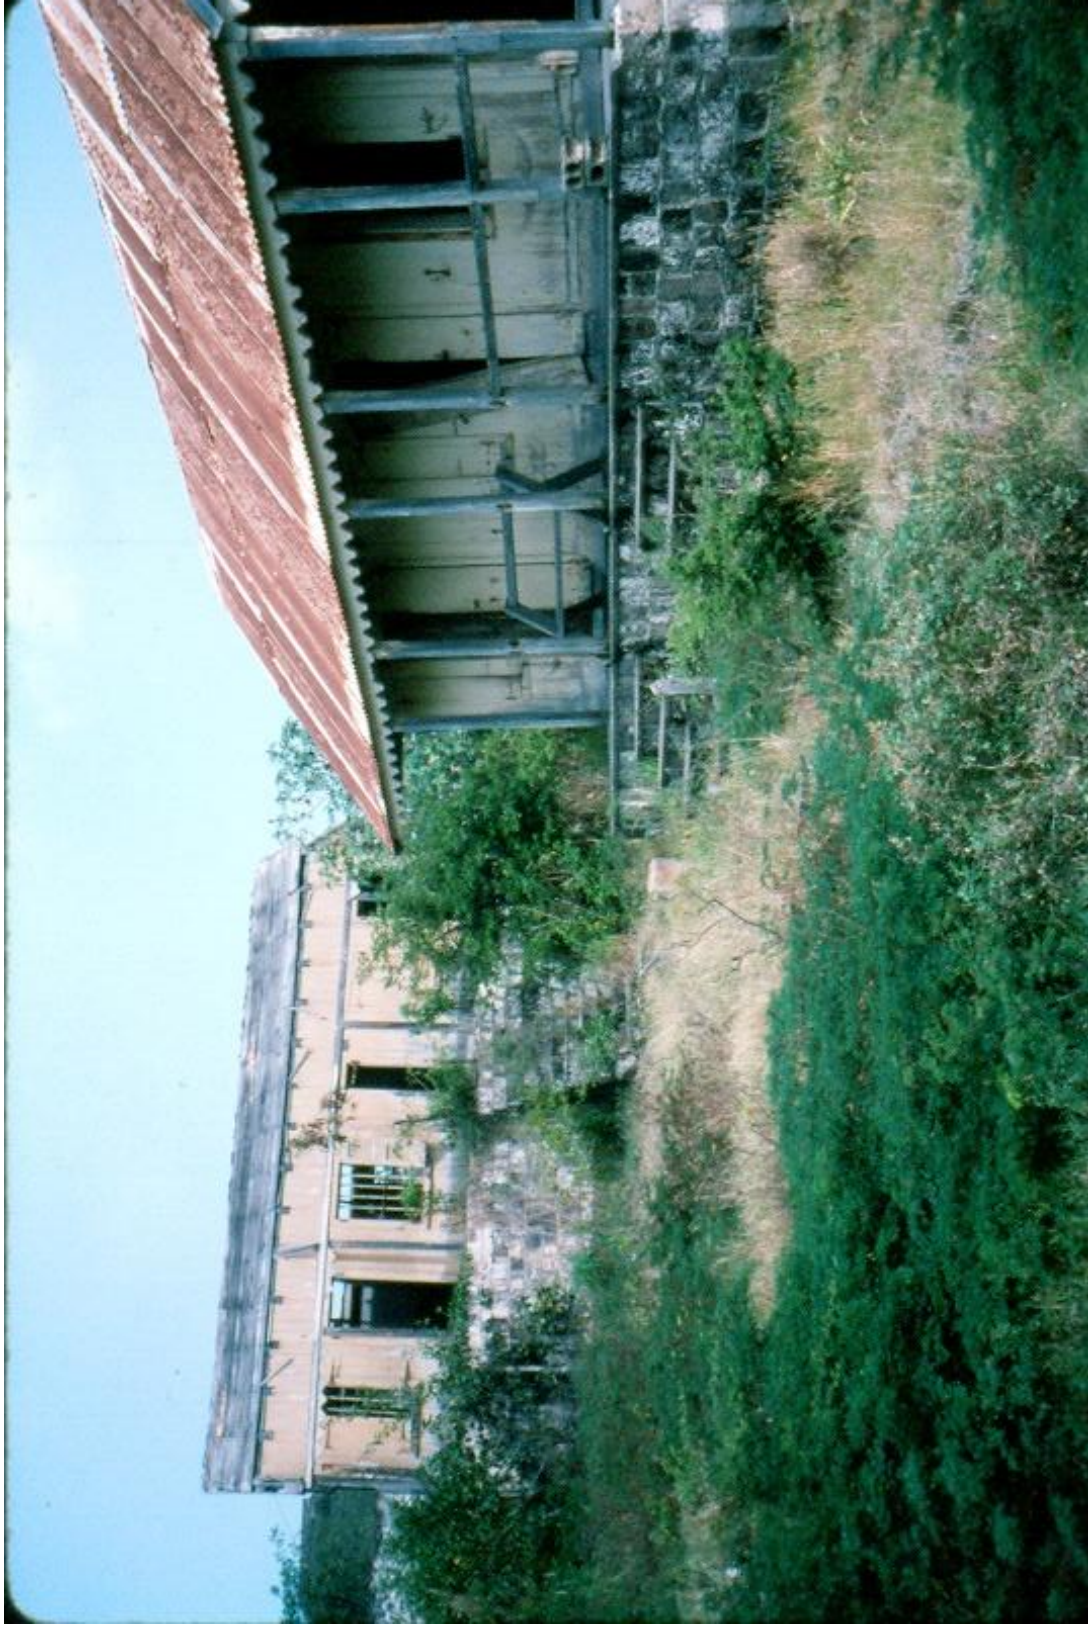
When recorded in 2000, Structure 16 consisted of the ruins of a post and beam building constructed on an elevated stone foundation (Schroedl 2000a:20-21; 2000b: Figure 50). Few architectural details were determined from the building's debris, except that it had been a detention building as evidenced by the vertically barred windows. As seen in the photograph of the structure taken in 1997, there is a porch running the length of the north facade; the roof of the porch is missing and the roof covering is completely gone. No porch railing is evident in the 1997 photograph too, although it seems likely there once was one. Figure 2 shows three entrances and three barred and

shuttered windows. Their positioning suggests that the structure may have been partitioned into three rooms, each with its own entrance and window.

Figure 2. Structure 16, detention building, north elevation, note the barred windows; Structure 18 is at the right, view to the south.

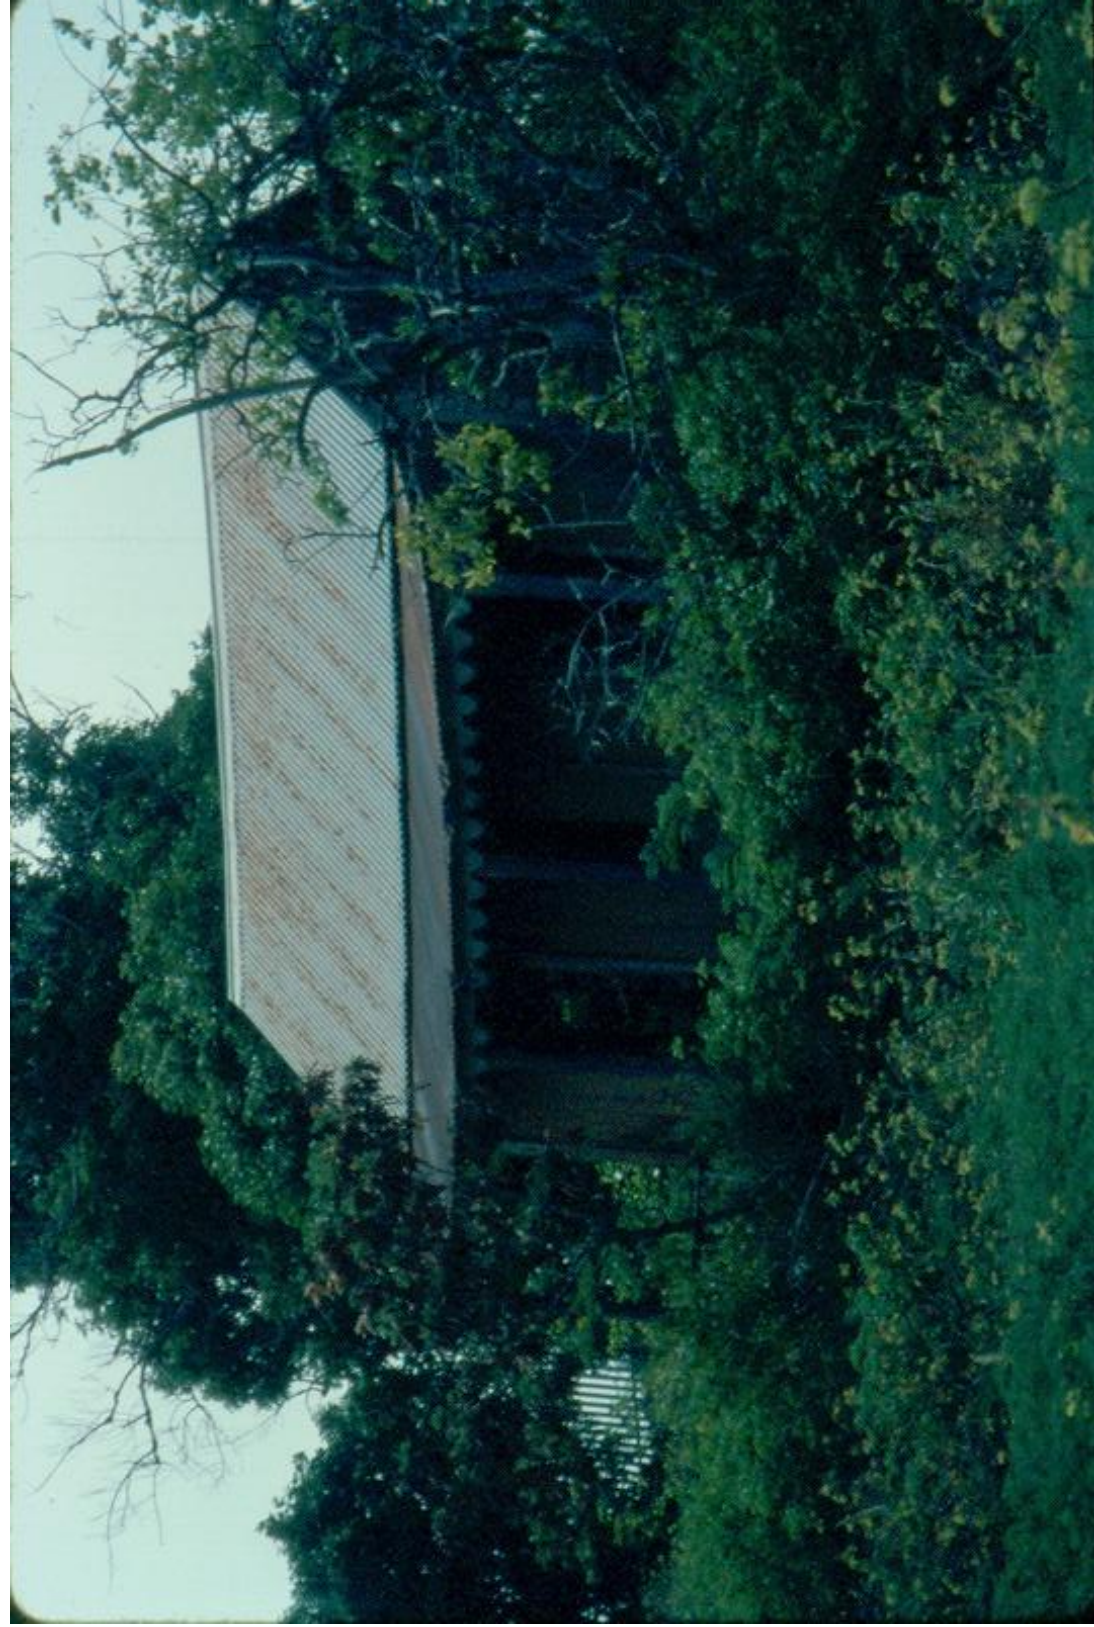
Structure 34, located on the north side of the fortress, was used to house hospital patients. Structure 34 is one of three buildings shown in the V.E. John picture postcard of the fort's interior taken in the 1920s or 1930s (Schroedl 2000a: Figure 3). When observed in May-June 2000, the structure was barely standing. The porch on the south side of the building was completely collapsed, the rear or north wall had fallen, the roof was almost completely missing, and the building was leaning precipitously to the north (Schroedl 2000b: Figures 83, 84, and 85). The photograph taken in 1997 (Figure 3) shows that the overall condition of the building was comparatively good at that time, and that particularly, the porch was standing and the corrugated metal roof was still in place. The decorative fascia board below the roof line of the porch is clearly visible in Figure 3. Similar decorative pieces occur on Structures 16 and 18 (Schroedl 2000a: 20-21, 22-23) and are visible on both Structure 34 and the kitchen building (Structure 4) in the V.E. John photograph.

Figure 3. Structure 34, patient housing, note decorative porch trim, view to north-northwest

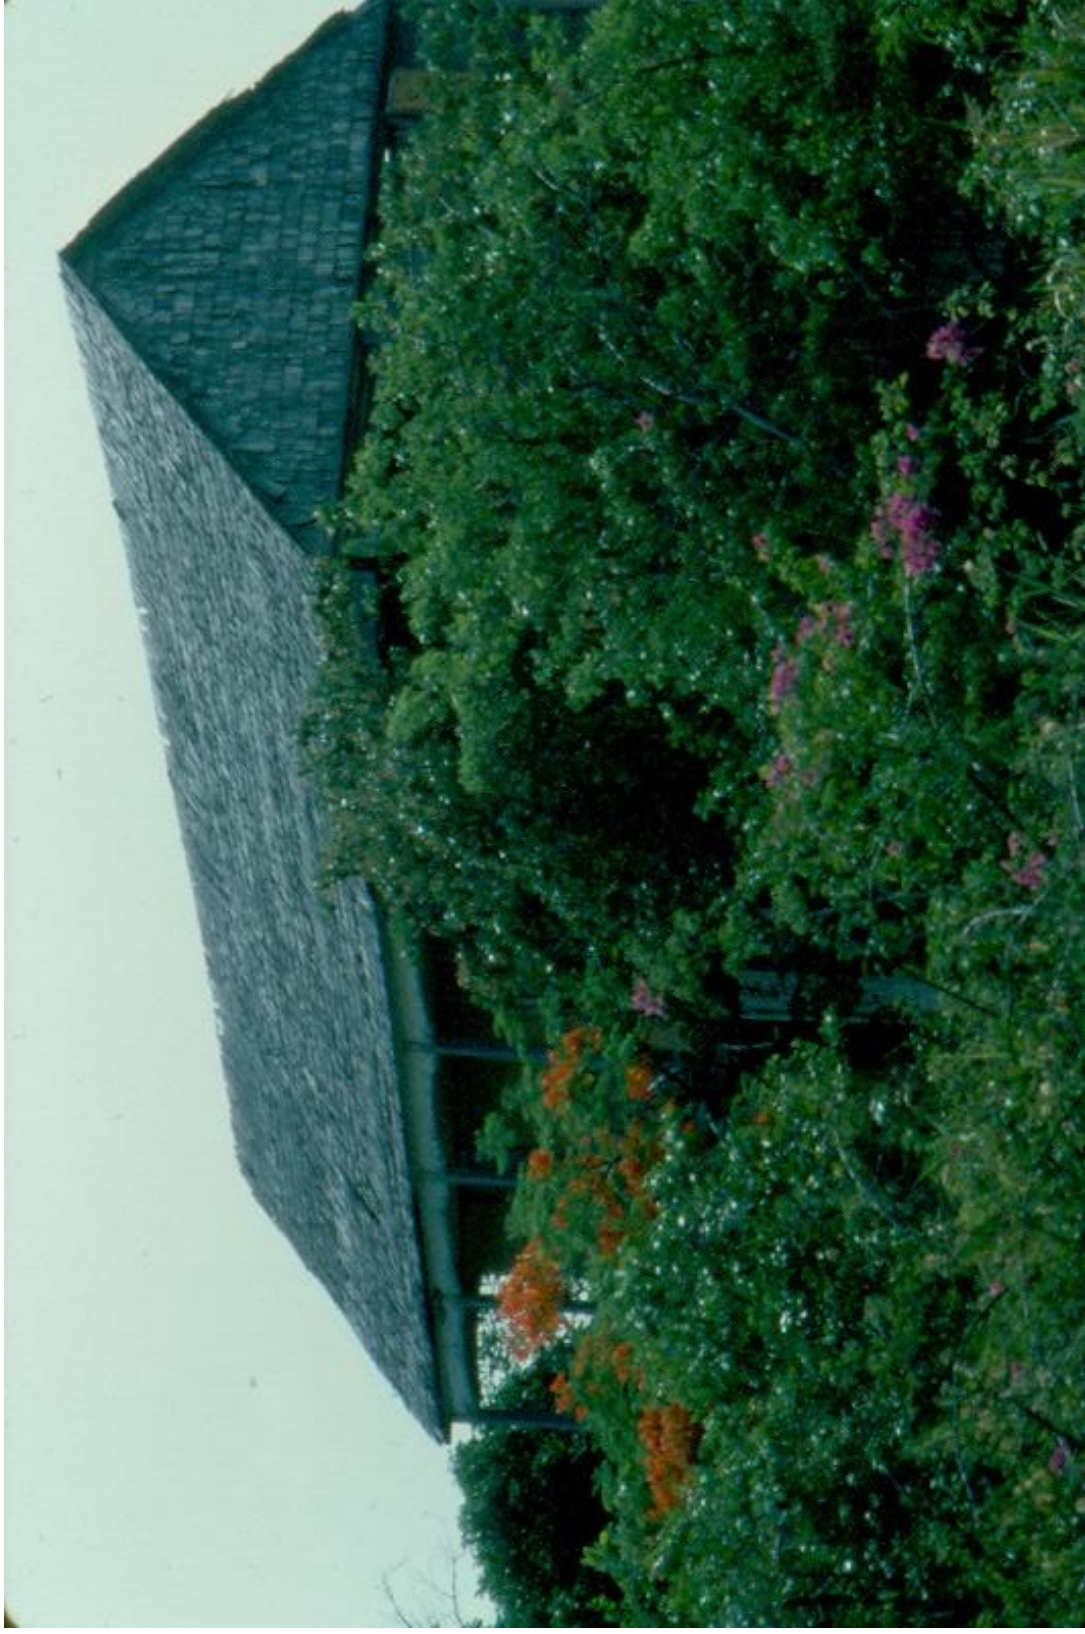
Structure 36 is a multi-room, two story patient dormitory, located on the north side of the fortress adjacent to the defensive wall (Schroedl 2000a: 33-34). The walls and support piers of this structure were collapsed with the roof resting on the debris in 2000 (Schroedl 2000b: Figures 88, 89, and 90). Figures 4 and 5 are from the visit in 1997. While vegetation obscures most of the structure in Figure 4, the porch posts and the undecorated trim between them are visible. It is also clear that the principal gabled roof covers the porch on the upper story. This type of porch construction occurs on other buildings at Charles Fort such as Structures 7, 11, 16, and 18 shown in Figures 1

Figure 4. Structure 36, patient dormitory, note wood shingle roof, view to north-northwest

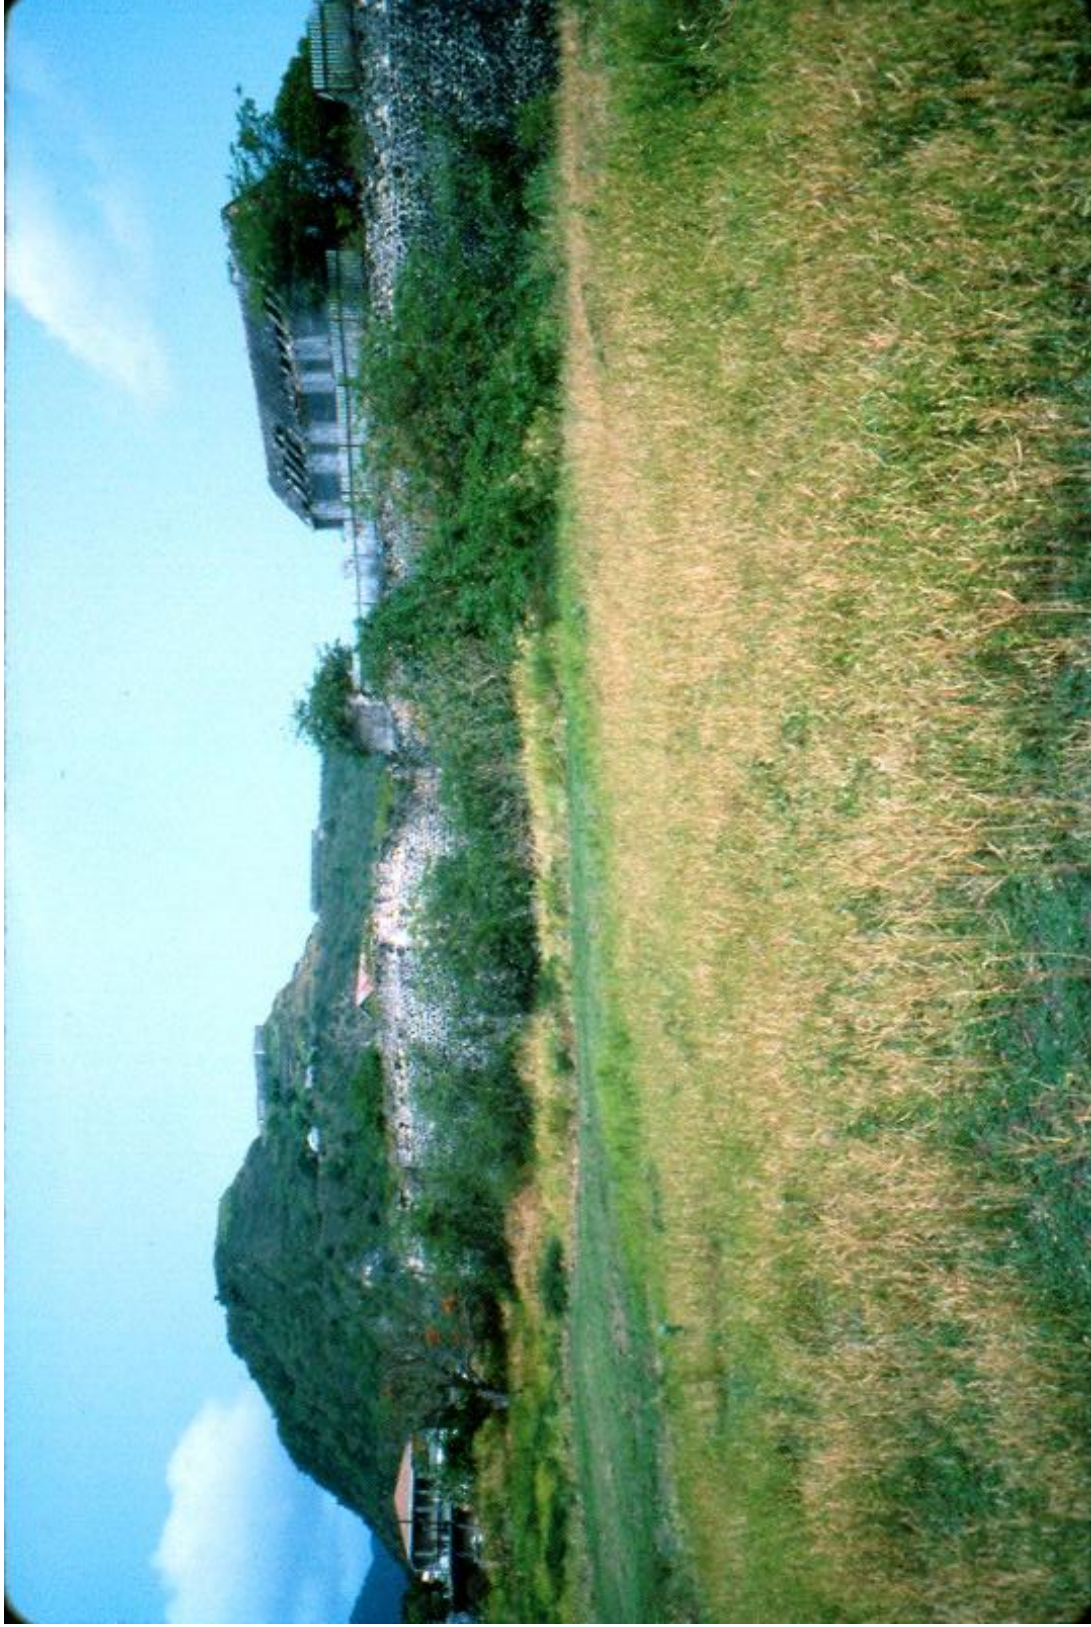
and 2, but that secondary or extended porch roofs also are evident as in Structure 34 (see Figure 3). The view of Structure 36 shown in Figure 5 is from outside the fortress wall. The northeast bastion shows at the left and Brimstone Hill is in the background. Five shuttered windows are visible on the structure's north elevation (a probable sixth window is obscured by vegetation). This photograph shows that part of the wood shingle roof had already been lost on the this side of the building in 1997, suggesting rapid deterioration after the hospital was closed or alternatively indicating that the building had been abandoned prior to this event.

Figure 5. Charles Fort north defensive wall and northeast bastion, Structure 36 shows at the right; roof of Structure 3 is visible at the center; Brimstone Hill fortress is in the background, view to the south-southeast.
